Technical Bulletin

Tech002 -2024 – 2011-2014 Ford 6.7L Dyno Service Replacement Pedestal Interference

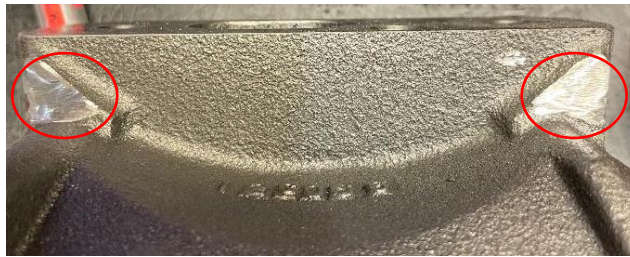
We have recently found out that there is a potential interference between the compressor stage of the turbocharger and the OEM pedestal.

Customer will need to check fitment due to casting variation in pedestal and compressor stage.

If there is interference which doesn't allow pedestal to have proper seal to center housing of turbocharger, then the Pedestal will need to be modified for proper seal and fitment.

To remedy to this issue, customer will need to Grind / Machine 2 spots down by about 2mm (0.079 inch) on the pedestal near the area of interference by the compressor stage bolt locations.
