Source:	Prestolite Electric Ltd - Greenford, London, UK
Date:	February 23, 2016
Bulletin No:	TSB4068 rev.1
Models:	DAF Starter motors
Subject:	AFTERMARKET FITMENT OF STARTER

AFTERMARKET INSTALLATION OF M90R3543SE / M90R3544SE

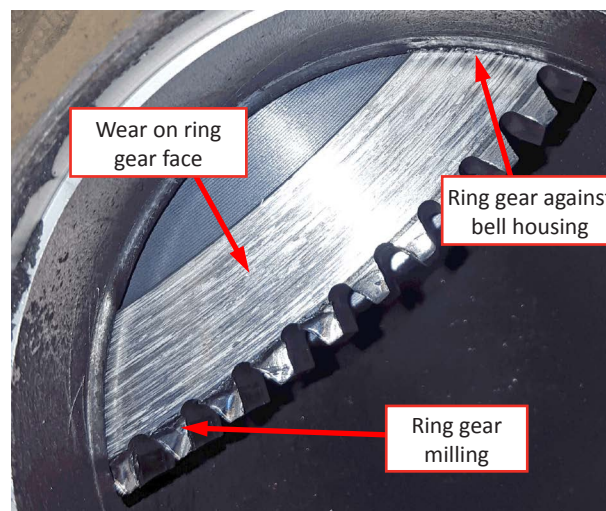
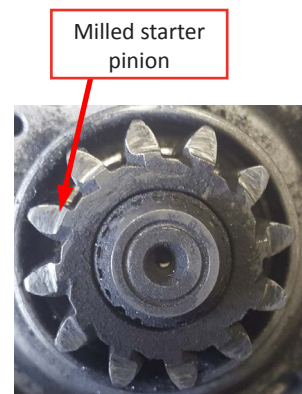
Defect / problem: Excessive wear to the crankshaft thrust bearings = starter failure

Symptoms: Oil leaks
Excessive crank/clutch end float
Flywheel contacts the bell housing (extreme cases)
Premature starter failure

Effect: Starter motor shaft fracture / Starter stuck in mesh.
(As the engine thrust washers wear this allows the flywheel to move towards the starter motor; and if sufficient wear occurs starter failure will result due to the loss of the necessary out of mesh clearance.)

We advise the close inspection of the engine, check for signs of oil leaks, crank / clutch float, contact between ringgear / bell housing, before replacing the starter motor. Also inspect old starter for signs of milled pinion.
Due to the nature of the cause of failure being outside the control of Prestolite, such warranties may not be accepted.
