Source: Leece-Neville Heavy Duty Systems Division - Arcade, NY USA  
Date: July 7, 2007  
Bulletin No: TSB-1106  
Models: MFY Starters  
Subject: Subject: MFY Starter Solenoid Change

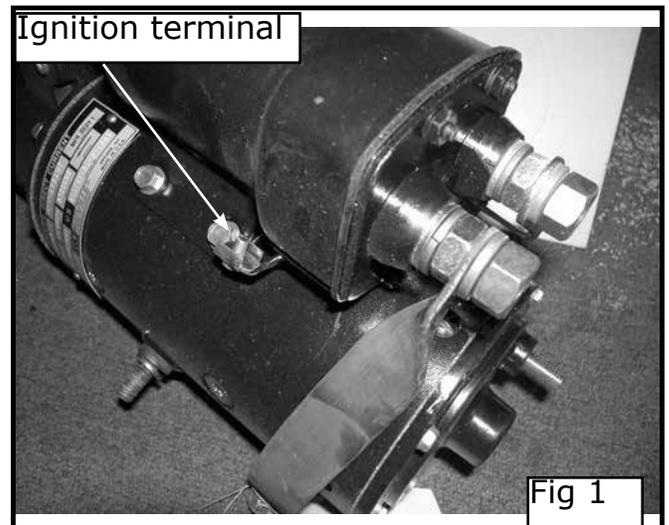
In Fig 1, shows an image of an MFY 6701UT with an SAT 4108UT solenoid.

Note the location of the ignition terminal on this starter.

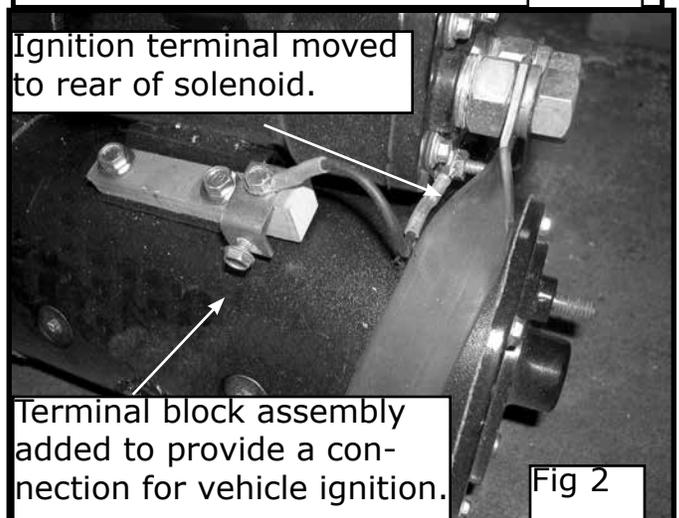
The SAT 4108UT solenoid is now discontinued and replaced with the S214102585S. As you can see in Fig 2 the ignition terminal has been moved and a terminal block assembly added to provide a connection point for the vehicle ignition wire.

Note: S214102585S comes with all the hardware needed to make this conversion.
