Source:	Prestolite Electric Ltd - Greenford, London, UK
Date:	March 17, 2020
Bulletin No:	TSB4071 rev.1
Models:	AC203RB alternator with sliding bush
Subject:	SLIDING BUSH DESIGN MODIFICATION

AC203RB SLIDING BUSH MODIFICATION

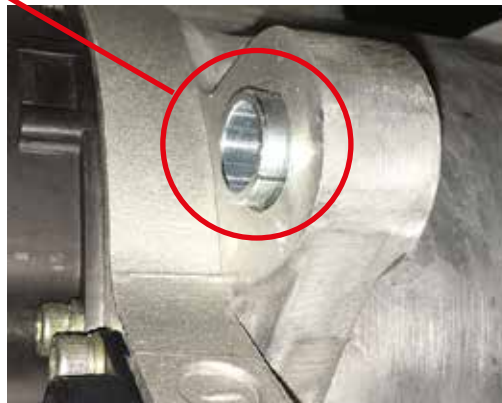
Prestolite have introduced a revised split bush / sliding bush for use on the AC203RB alternator range, fitted to the mounting lugs on the stator 6332-A1479. Two bushes fitted per alternator.

The new bush, part number 6270-691, has been re-engineered by increasing the wall thickness and changing the material to a higher grade steel, providing the required sprung force for the application.

The internal diameter of the bush remains unchanged to ensure identical engine interface, however the external diameter of the bush has increased.

All stators manufactured from date code P500 382018 (17 Sept 2018) will have the new specification split bush fitted.

NOTE: The new specification bush, 6270-691, cannot be used on stators manufactured before date code 382018 (17 Sept 2018) without also modifying the stator. (See instruction on page 2)

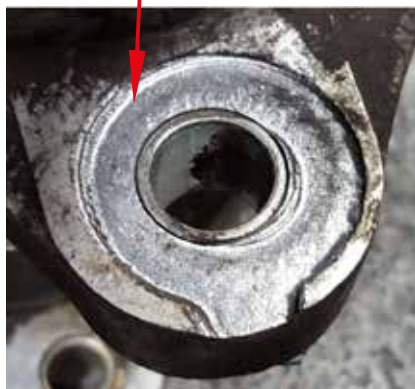
Visually inspect stator lugs for wear or ovality. See examples of unacceptable wear below. Ovality or wear to the stator casting that prevents secure mounting or potentially lead to misalignment is not permitted. The stator should be replaced.

Wear to housing face

1. Check visually for any wear or ovality to the bush or stator lug as outlined in inspection guidelines above.
2. Press the old sliding bush out and replace with new bush 6270-691.
Bush must be an interference fit.

1. Check visually for any wear or ovality to the bush or stator lug as outlined in inspection guidelines above.
2. Drill the hole to diameter 21.50 / 21.65mm, retaining concentricity with stator centreline.
3. Fit new bush 6270-691.
Bush must be an interference fit.

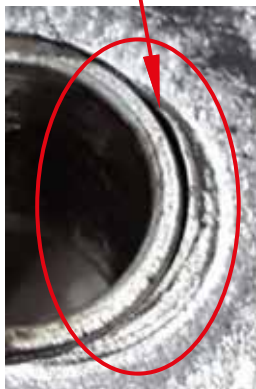
Ovality

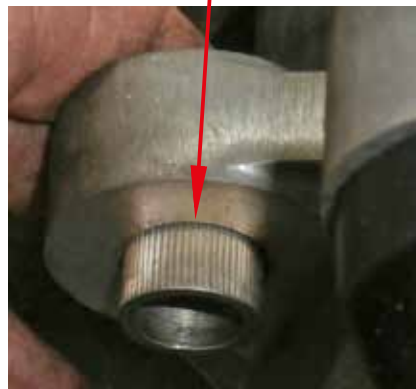
Loose fit
